U S. ENVIRONMENTAL PROTECTION AGENCY
 POLLUTION/SITUATION REPORT
 ESI-PRP Removal - Removal Polrep

Subject: POLREP #27
 Progress
 ESI-PRP Removal
 B5YS
 Indianapolis, IN
 Latitude: 39.9128600 Longitude: -86.2423680

From: Verneta Simon & Anita L. Boseman, On-Scene Coordinators
Date: 10/24/2011
Reporting Period: 10/17/2011 - 10/21/2011

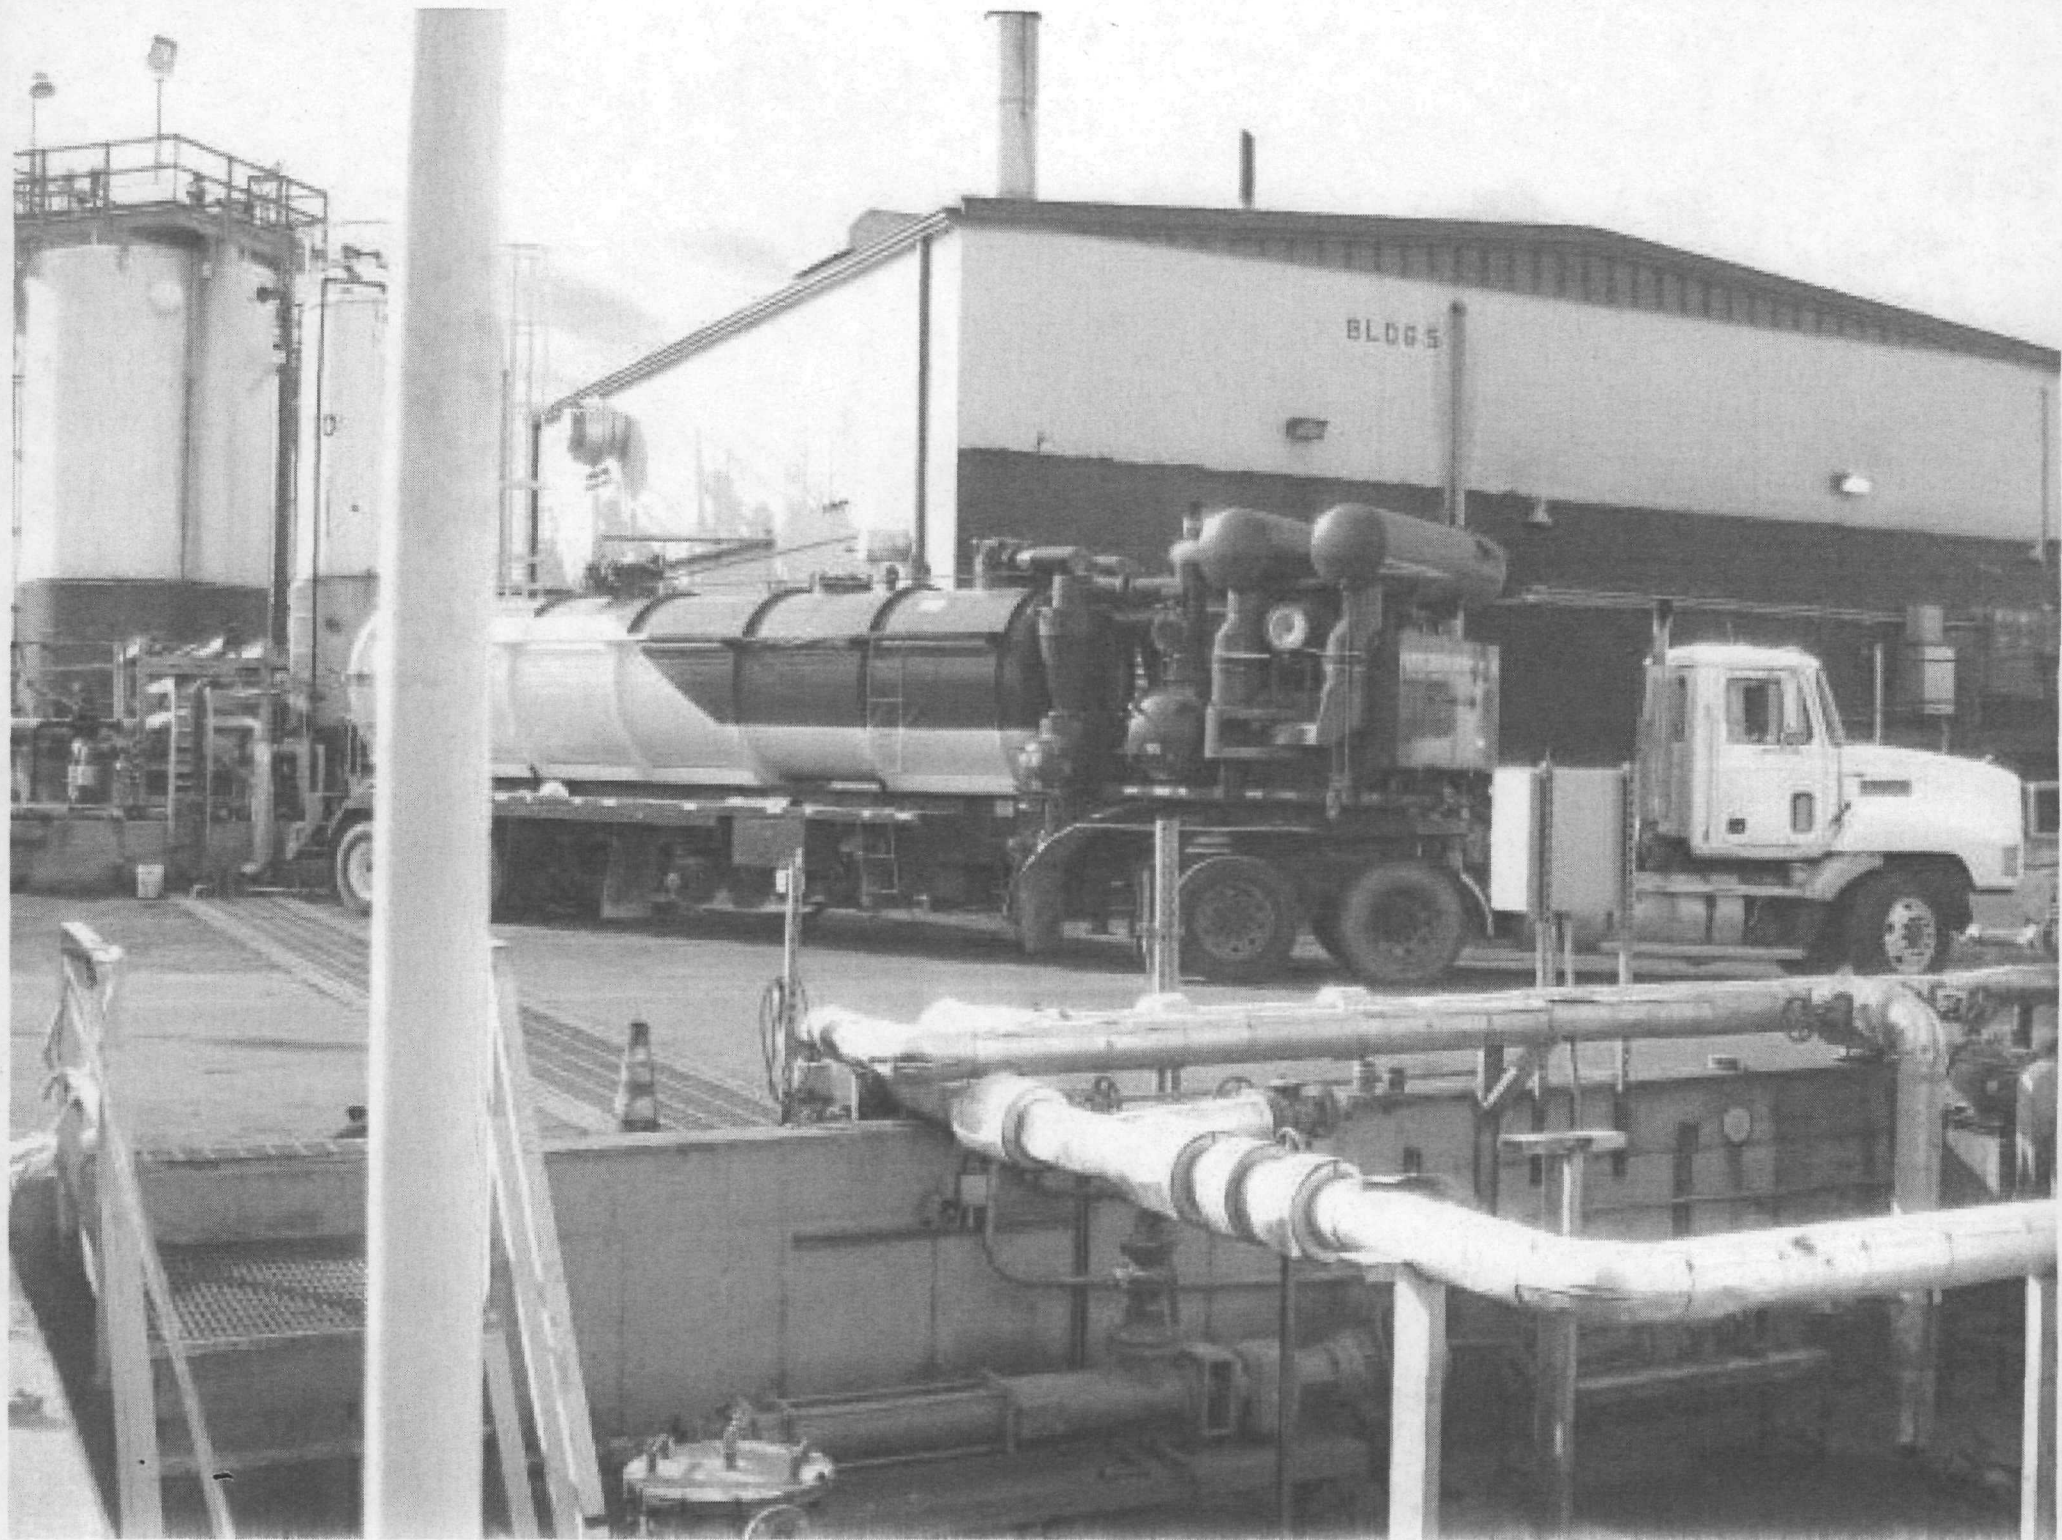
- Trihydro treated stormwater with the GAC system
- Trihydro requested visual inspection of the northeast sludge tank in the solids building The tank is called "Tank 22" in EPA documents but is labeled Tank 24 There were no visible product residues after the cleaning process The condition of the tank was documented with two photos of the interior
